Infiltration & Inflow Investigation Achieves an “As Tight As Possible” Collection System

Presented to
Council Committee-of-the-Whole Meeting
Bettendorf, Iowa
June 15, 2009

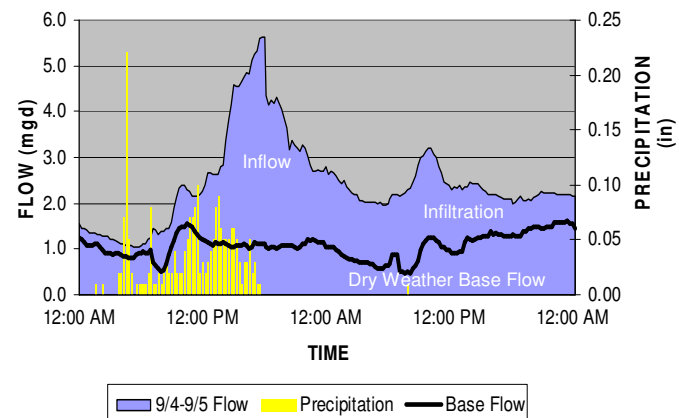
BASIN 19 FLOW and PRECIPITATION vs TIME SEPTEMBER 4, 2008 - 2.18"

Basin 19 has Significant I&I

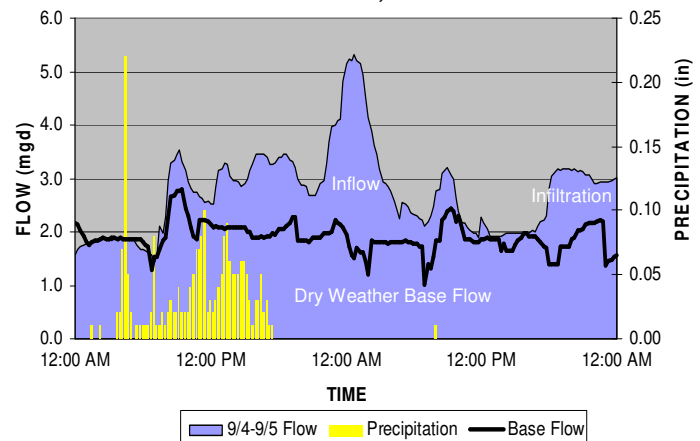
BASIN 5 FLOW and PRECIPITATION vs TIME SEPTEMBER 4, 2008 - 2.18"

Basin 5 has Significant I&I

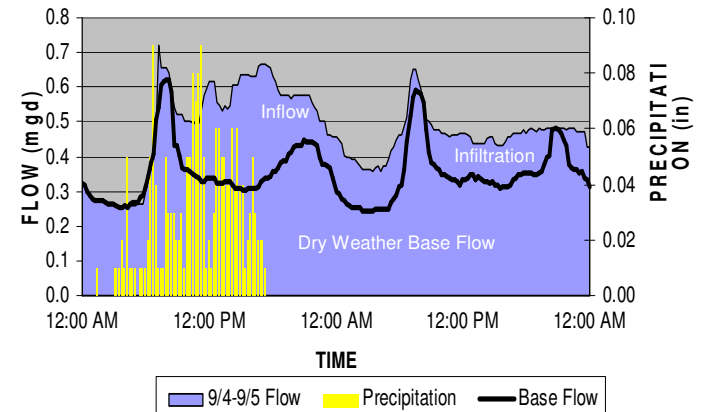
BASIN 17 FLOW and PRECIPITATION vs TIME SEPTEMBER 4, 2008 - 1.89"

Basin 17 has Significant I&I

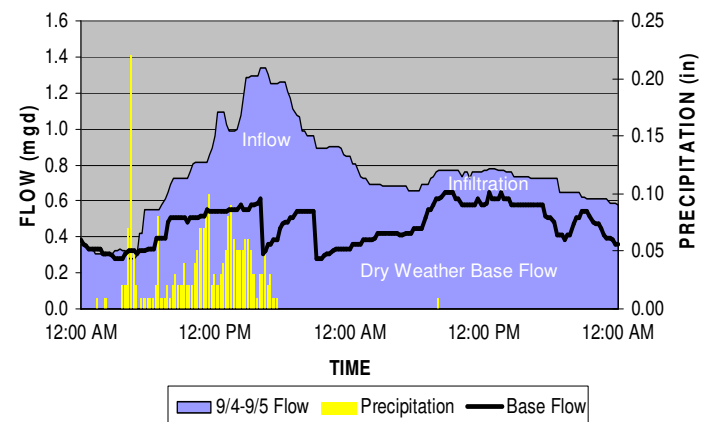
BASIN 2 FLOW and PRECIPITATION vs TIME SEPTEMBER 4, 2008 - 2.18"

Basin 2 has Significant I&I
